DAVINCI  
VALVES™

## INSPECTION REPORT

**Product:** Knife Gate Valves

**Service Type:** **PRE-SHIPMENT INSPECTION**

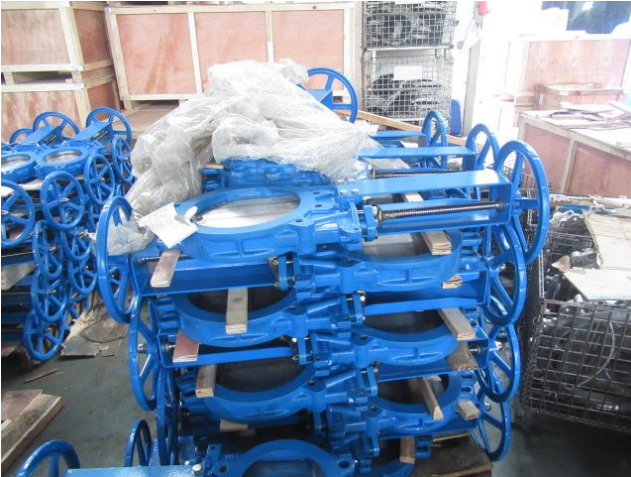
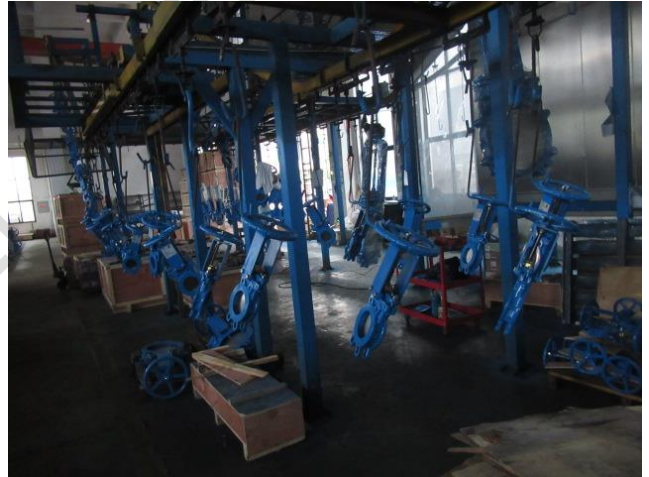
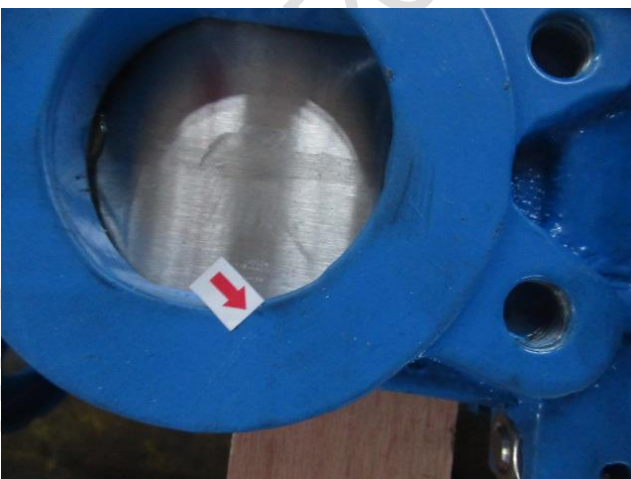
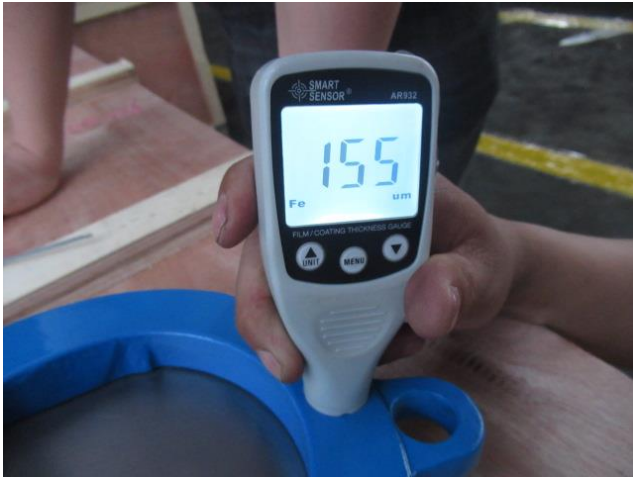
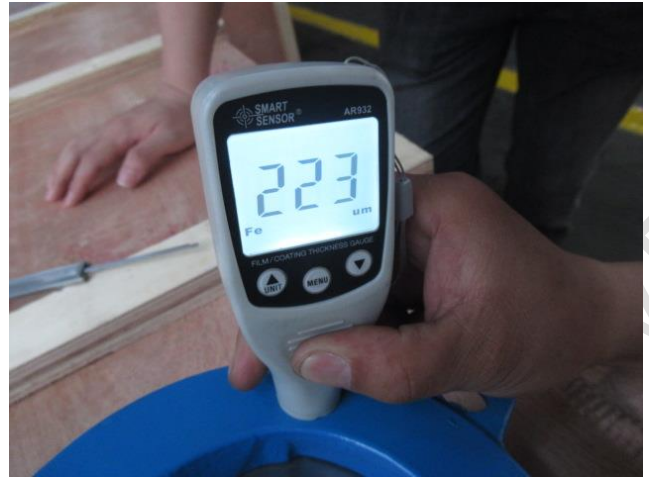
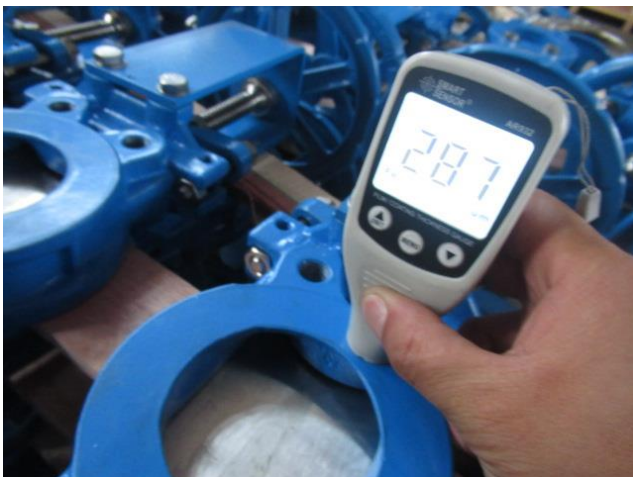
**A.2. For DN80 and DN 100 / DN125**  
*Factory finished fit, but no clean it, so dirty mark on product -100%.*

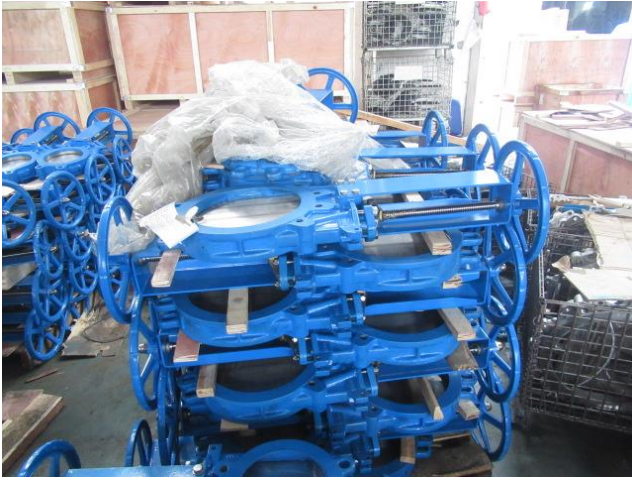
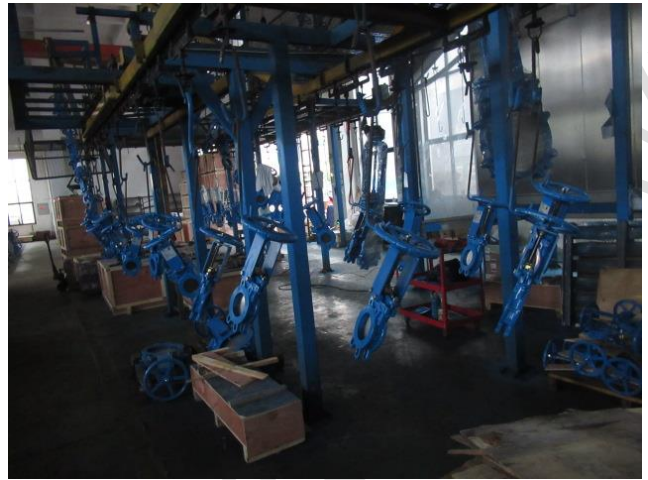
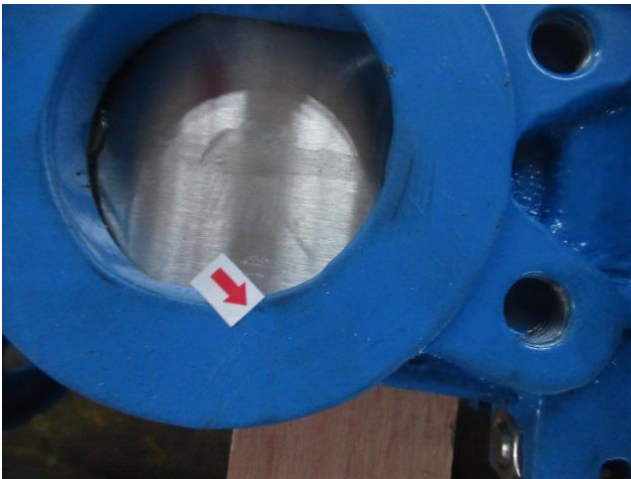
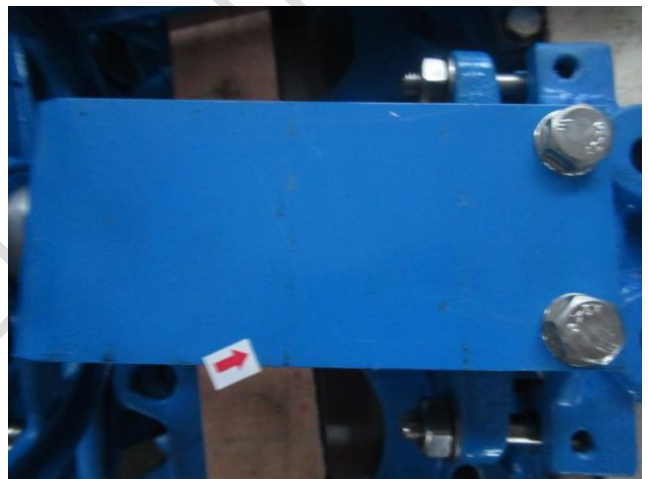
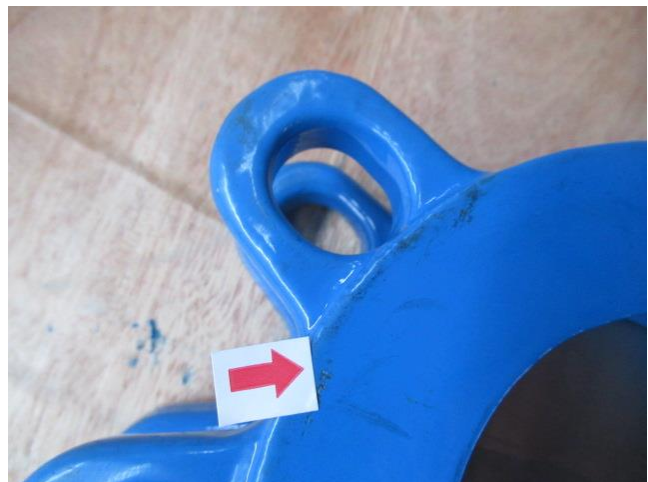
## D. WORKMANSHIP DEFECTIVES

As all sample no clean, so dirty mark on product -100%.

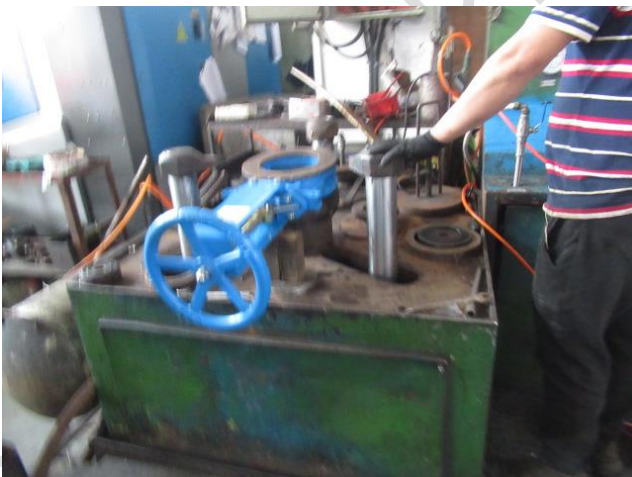
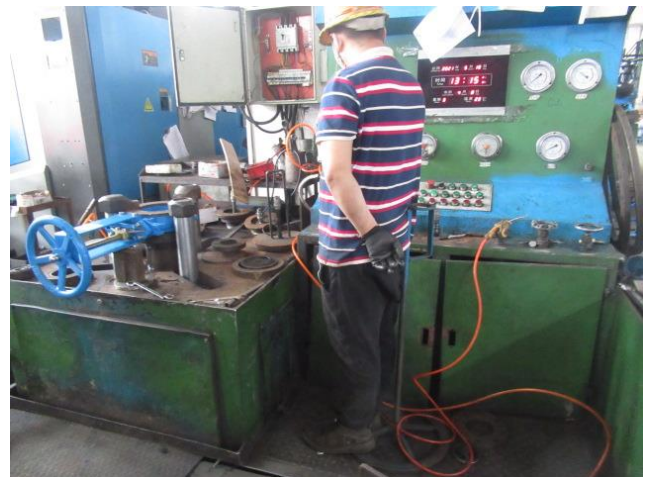
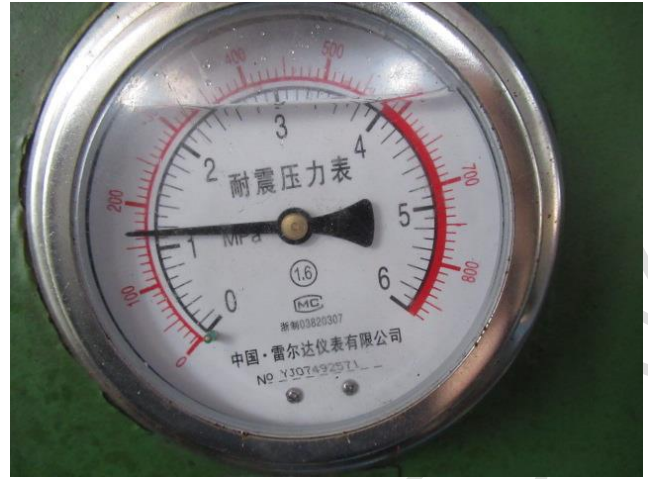
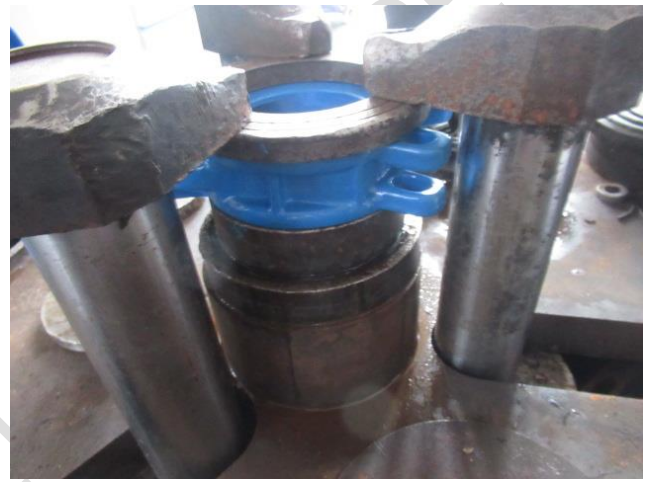
### Pictures for testing:

**Obturator test:** Pressure test was performed by factory staff under the guidance of inspector, the rated pressure for each item tested is 1.2 Mpa(Pressure =  $1,1 \times PN$  ,  $PN=1.6\text{MPa}(16\text{bar})$ ), the pressure will be increased gradually from 0 to 1.2 Mpa, when it reached 1.2 Mpa, it will keep 0.15~2 minutes(30s for DN80~125), The test shall show no leakage through the metal, pressure containing joints, or stem seals;

**Shell test:** Pressure test was performed by factory staff under the guidance of inspector, the rated pressure for each item tested is 2.4 Mpa(Pressure =  $1,5 \times PN$  ,  $PN=1.6\text{MPa}(16\text{bar})$ ), the pressure will be increased gradually from 0 to 2.4 Mpa, when it reached 2.4 Mpa, it will keep 0.15~3 minutes(15s for DN50,60s for DN65~60 180s for more than DN250 ), The test shall show no leakage through the metal, pressure containing joints, or stem seals;

This painting test was by a hammer as factory had no test equipment.

The painting test Factory make indenter (0.5kg) free fall at 1 m height, slight dent was found after test.

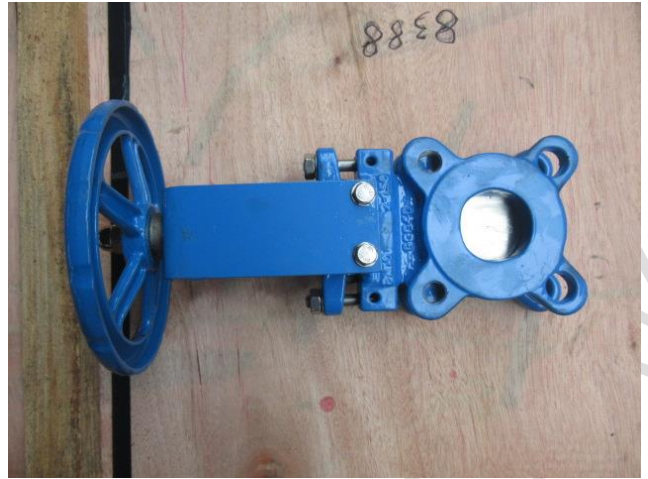
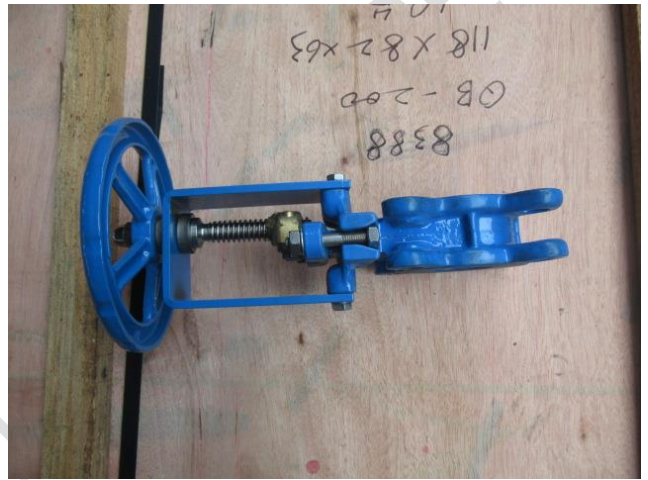
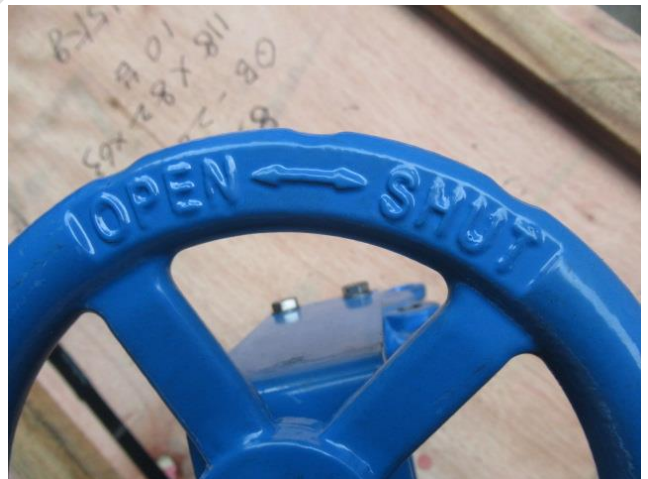
### DN50 BEFORE WASHING LINE NOT FINISH

Valves have to be packed inside the wooden box, but shipping mark on it for DN150/200/250.  
Without packing side, the wooden box for DN 80/100/125.
